# Solvay Barium Carbonate

Information on the prevention  
of efflorescence on bricks and tiles

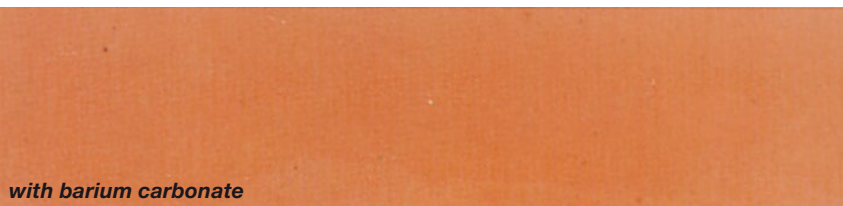
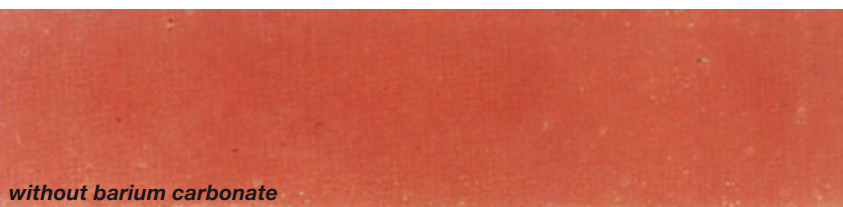
#### Illustration No. 1

Example of drying-related efflorescence on a brick. The fired outer wall bricks can either be of a uniformly red colour over the whole surface (above with the addition of barium carbonate) or covered over with white to greyish-yellow deposits (below without barium carbonate addition)

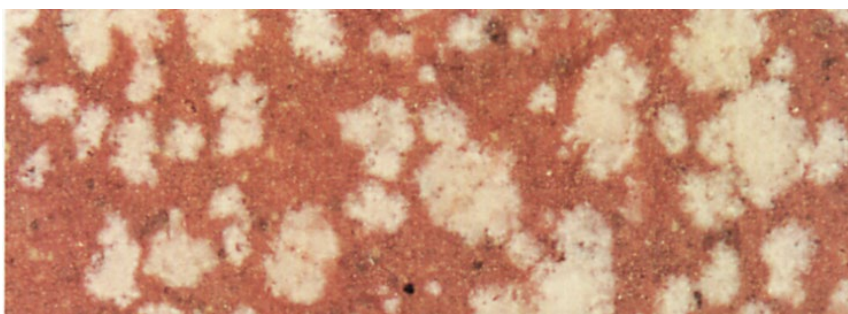
#### Illustration No. 2

Example of drying-related efflorescence on a brick – enlarged view. Under the microscope it becomes evident that a number of individual, almost white spots give the brick's surface an impure-looking, respectively discoloured overall appearance

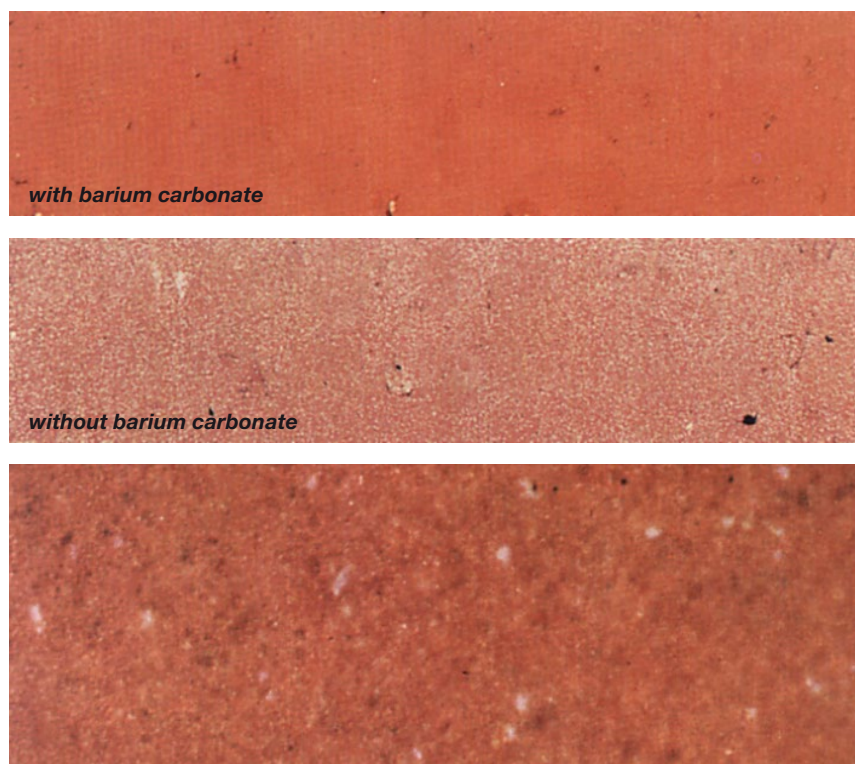
### Illustration No. 3

Example of drying-related efflorescence on a brick. In this picture, the difference between the surface of a brick produced with barium carbonate addition (above) and one produced without barium carbonate addition (below) is more plainly visible than in figure 1

Enlarged view showing a blank containing barium carbonate. Compared with figure 3, the microscope photo clearly shows the homogeneity of the blank with barium carbonate content. It can thus be concluded that no sulphates were carried to the surface during the drying process, i.e. that the salts are completely contained
