## NOCOLOK® News #2-2021

November, 2021

# Analysis of Brazing Imperfections by Metallographic Investigation / Optical Microscopy – Part 2

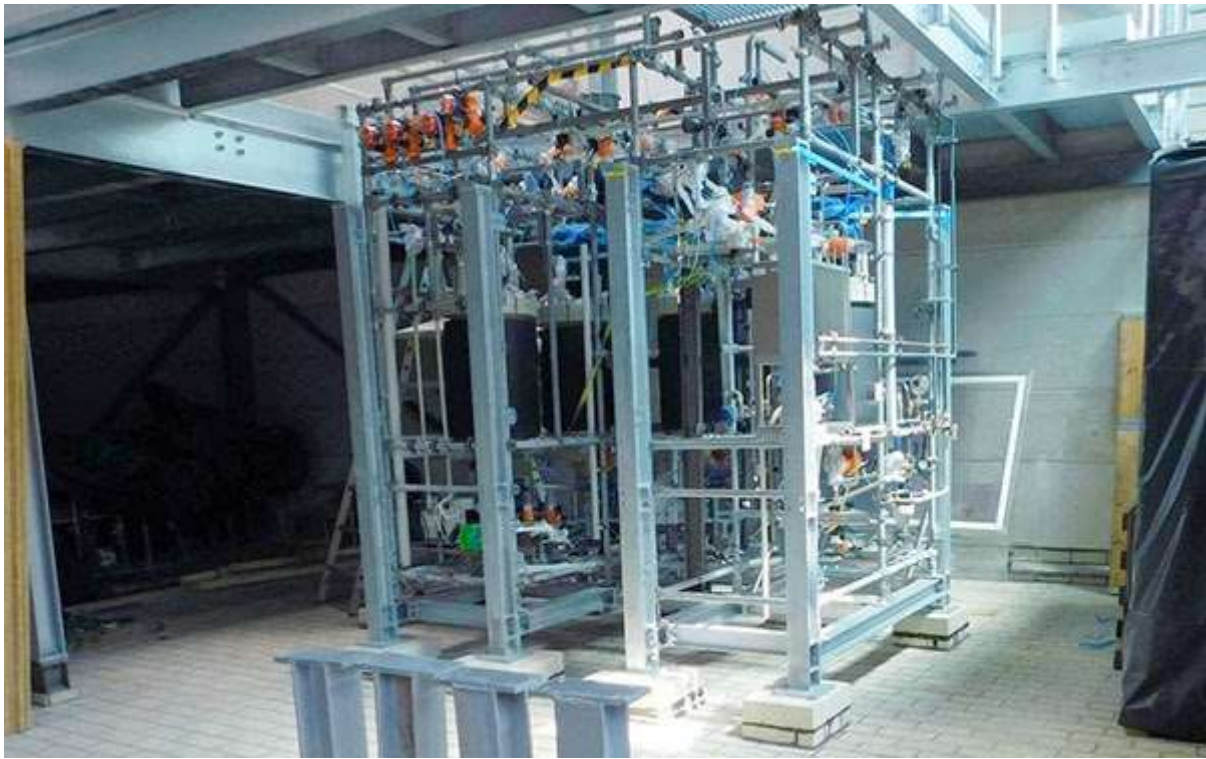
As reported in our last issue the Tech-Service, research and development departments (with our pilot line) will be transferred to the new Competence Center based in our Bad Wimpfen site. We are in line with all schedules. The pilot line is already under re-assembling as shown in the photo. The research part should be ready within this year. The Tech-Center will be installed within 2022 depending on the construction progress of the new buildings.
