# Using Fractography to Investigate Causes of Material Failure in Sulfone Polymers

Authored by Philippe Martin

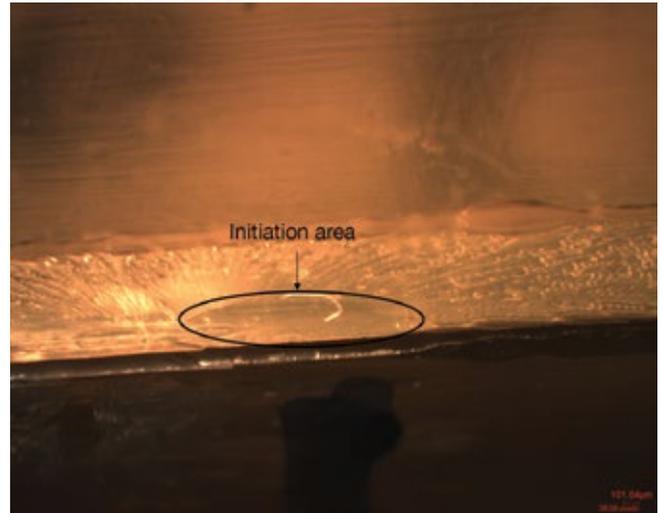
Static mechanical failure consists of the rapid propagation of a crack through the material which is under an external load. The fractured surface pattern is presented in Figure 2.

**Figure 2:** Surface fracture pattern typical of static mechanical failure in sulfone polymers

In static mechanical failure, the mirror zone is surrounded by hackles, which are divergent lines radiating outward from the fracture origin and pointing along the crack propagation direction. Hackles correspond to a more violent fracture such as a large absorption of strain energy through important plastic deformation (crazing or shear yielding). They result from crack branching when the propagation rate of the initial crack becomes too high. Hackles are generally located in areas where the stress field is changing rapidly in either direction or magnitude.

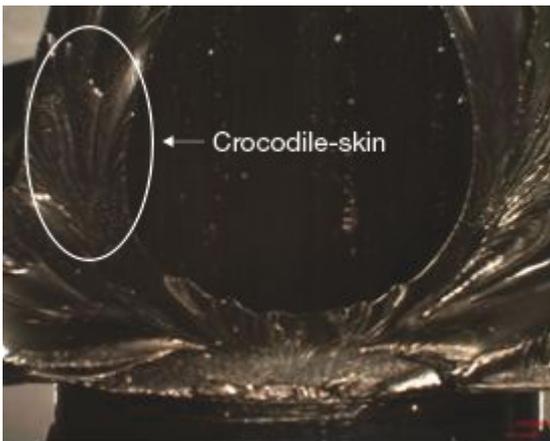
**Figure 4:** Crocodile-skin pattern subsequent to a mechanical failure as the propagation rate increased

Depending on the stress level applied to the parts, the rate of crack propagation can be more or less elevated. In the case of very high propagation rates, the fracture surface pattern is often more complex and a crocodile-skin pattern can be observed (Figures 3 and 4).

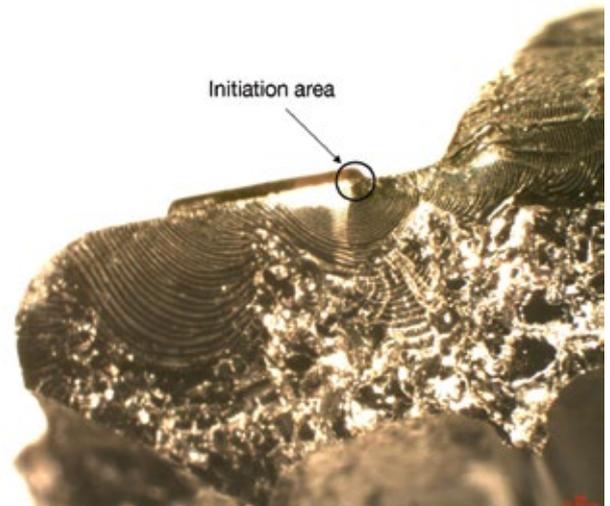
The pattern representative of dynamic mechanical failure is shown in Figures 5a and 5b. The deformation zone consists of successive striations (semi-elliptical lines) that emanate outward from the initiation zone. Each striation represents a true crack arrest marking and corresponds to crack-front position at each successive stress cycle.

**Figure 5a:** Typical fracture pattern of dynamic mechanical or fatigue failure in sulfone polymers

The initiation point corresponds to the area from where the striations emanate (Figures 5a and 5b). As for static

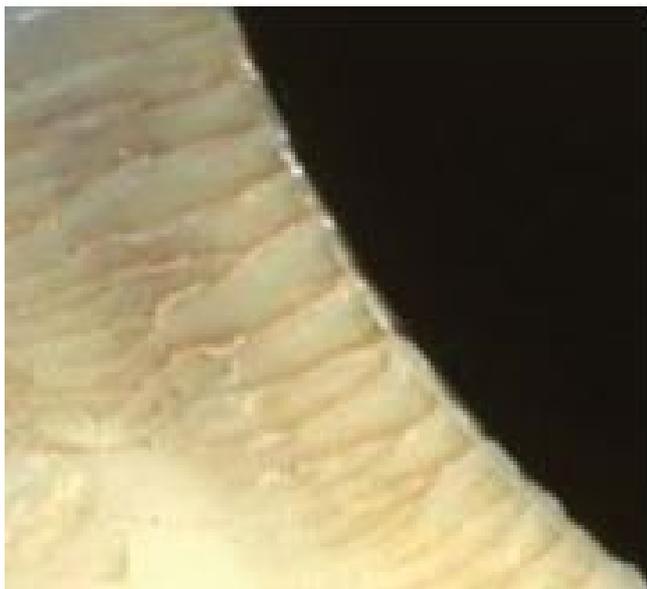
**Figure 9:** Fractured surface in Radel® PPSU part at high magnification. Pattern seems to be representative of chemical attack.

A preliminary general analysis of the fractured surface is very important in these cases. Indeed, as shown in Figures 9 and 10, a fracture pattern representative of a chemical attack with crazes parallel to the part surface can be easily confused with a fracture pattern representative of mechanical failure only if a localized analysis at high magnification is performed. Effective fractography must therefore always include a global analysis of the fracture surface.

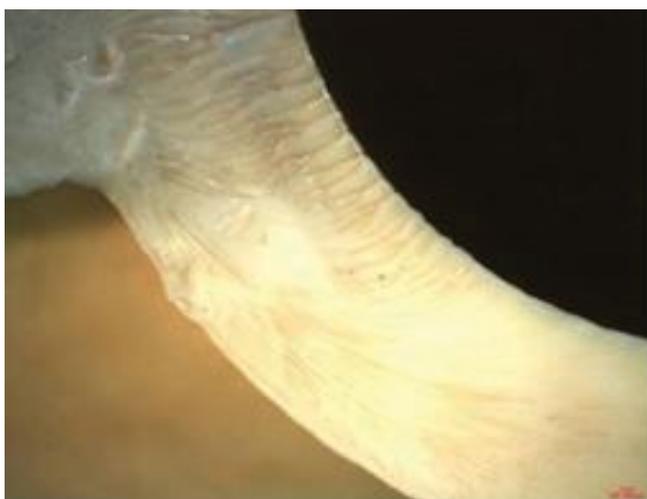
**Figure 10:** Fracture surface in the same part at low magnification. Pattern is clearly related to mechanical failure.
